DEPARTMENT OF TRANSPORTATION**DIVISION OF ENGINEERING SERVICES**

Contract #: 04-0120F4Cty: SF/ALA Rte: 80 PM: 13.2/13.9File #: 1.28**WELDING INSPECTION REPORT****Resident Engineer:** Casey, William**Address:** 333 Burma Road**City:** Oakland, CA 94607**Report No:** WIR-027069**Date Inspected:** 25-Jan-2012**Project Name:** SAS Superstructure**OSM Arrival Time:** 700**Prime Contractor:** American Bridge/Fluor Enterprises, a JV**OSM Departure Time:** 1530**Contractor:** American Bridge/Fluor Enterprises, a JV**Location:** Job Site**CWI Name:** Bernard Docena**CWI Present:** Yes No**Inspected CWI report:** Yes No N/A**Rod Oven in Use:** Yes No N/A**Electrode to specification:** Yes No N/A**Weld Procedures Followed:** Yes No N/A**Qualified Welders:** Yes No N/A**Verified Joint Fit-up:** Yes No N/A**Approved Drawings:** Yes No N/A**Approved WPS:** Yes No N/A**Delayed / Cancelled:** Yes No N/A**Bridge No:** 34-0006**Component:** Emergency Gates CCO-179**Summary of Items Observed:**

Emergency Gate Installation associated with CCO-179

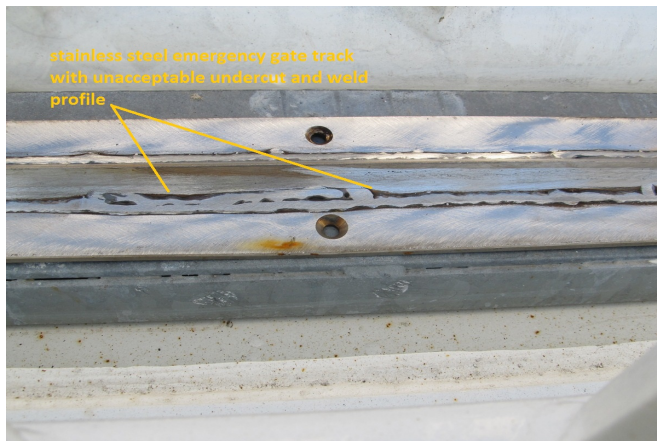
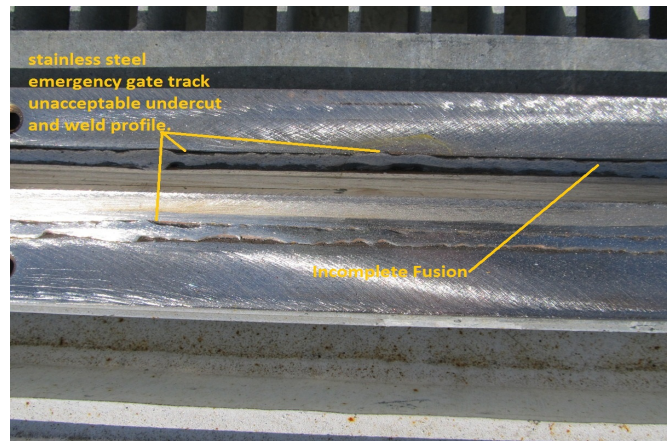
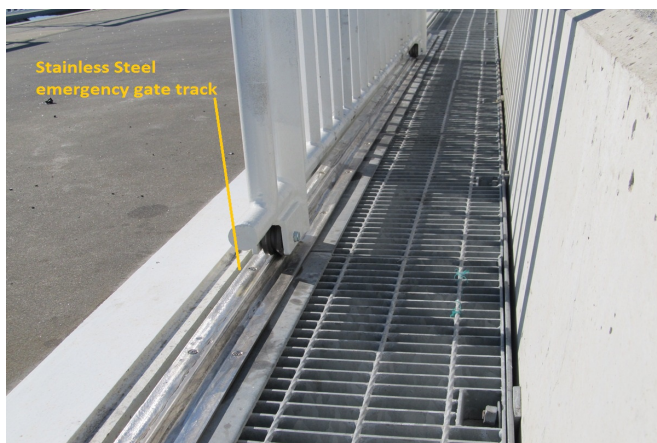
Gate #9-Rail #9

The QA Inspector randomly observed the ABF welder Jason Collins and ABF representatives Bradley Whitburn and Mathew Chamberlin fit up gate retainer, gate latch and stainless steel gate track at the above identified location. The QA Inspector noted the hardware had been previously placed at the location and the paint and galvanized coating had been removed on the existing rail for installation of the emergency gate hardware. The QA Inspector randomly observed the ABF welder fit up and tack weld the gate retainer bracket and gate latch to the existing rail. After they were tack welded in place the gate track was positioned for drilling and tapping the holes for the installation of the stainless steel screws. Once the gate was moving free and clear, the SE QC Inspector performed a visual inspection of the fit up. The QC Inspector informed the QA Inspector the fit up was acceptable. The QA Inspector performed a random visual inspection of the fit up and noted it did appear to be in general compliance with the contract documents for the exception of the stainless steel gate tracks welds.

The QA Inspector observed the ABF welder Jason Collins perform shielded metal arc welding (SMAW) of the restrainer bracket and gate latch for the above identified location. The QA Inspector noted the ABF welder was utilizing 1/8" E7018 low hydrogen electrodes with 122 Amps. The QA Inspector noted the SMAW parameters did appear to be in general compliance with the contract requirements. The QA Inspector noted the ABF personnel did not complete the installation of the above identified emergency gate on this date.
